Why Source Removal?

An overview of source removal sites in Montana

Case Incident #1 - Absarokee Bus Barn

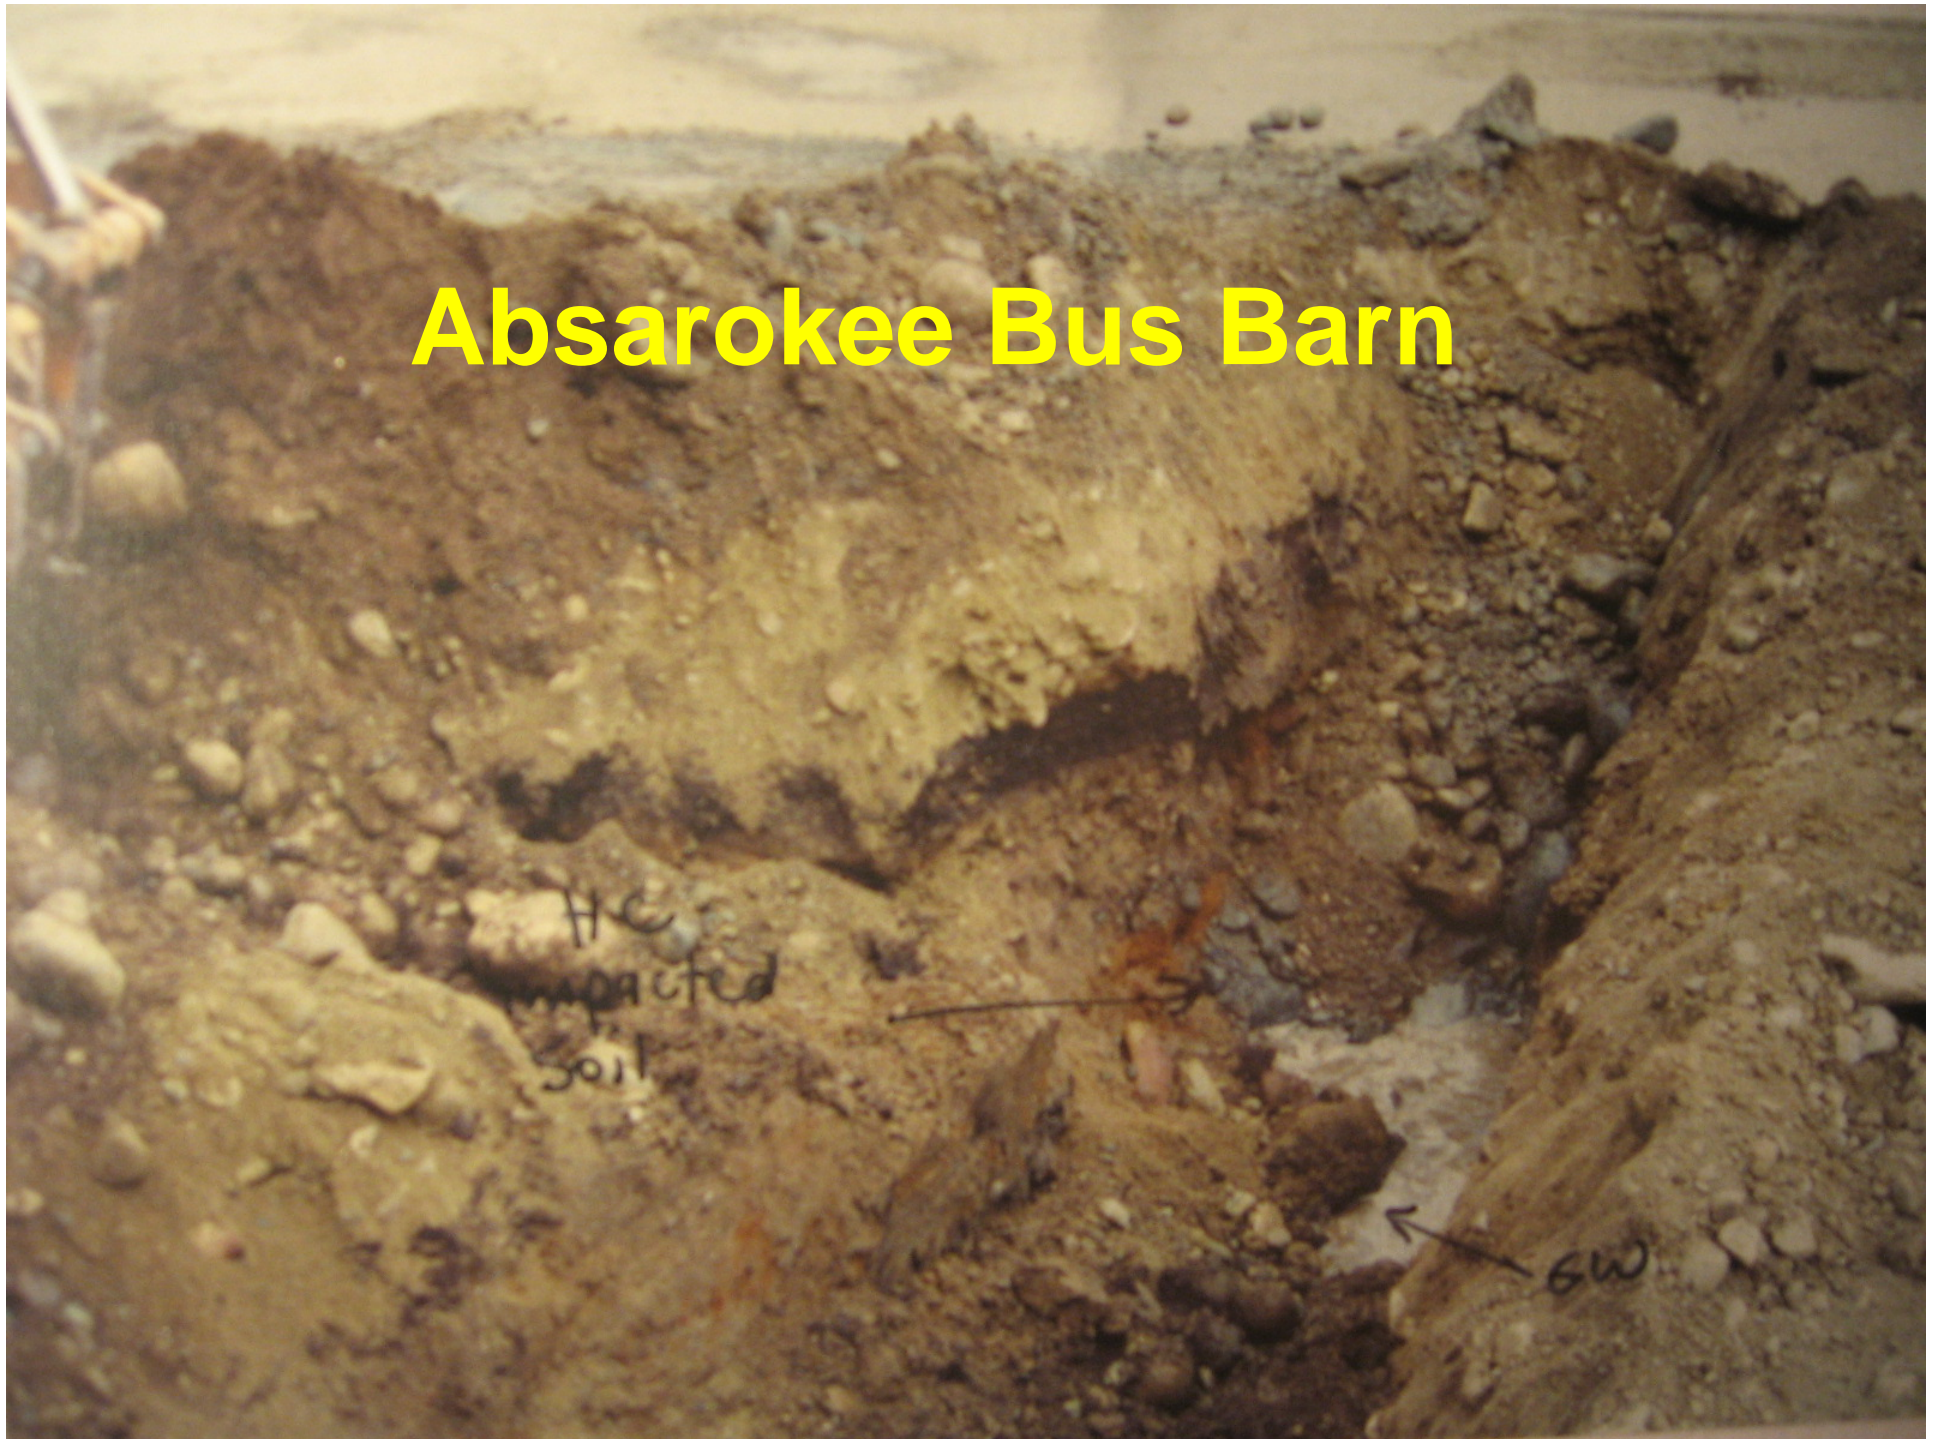
- 1,000 gal. gasoline UST removed 1998
- Cause of release: overfills
- 18 cubic yards excavated
- Coarse sand and gravel aquifer
- Shallow water table, approx. 5 feet bgs

- 18 cubic yards treated in an on-site biopile
- 10,600 ppm TPH in soil in contact with groundwater
- Sheen on water table
- 3 monitoring wells installed
- Low dissolved BTEX concentrations

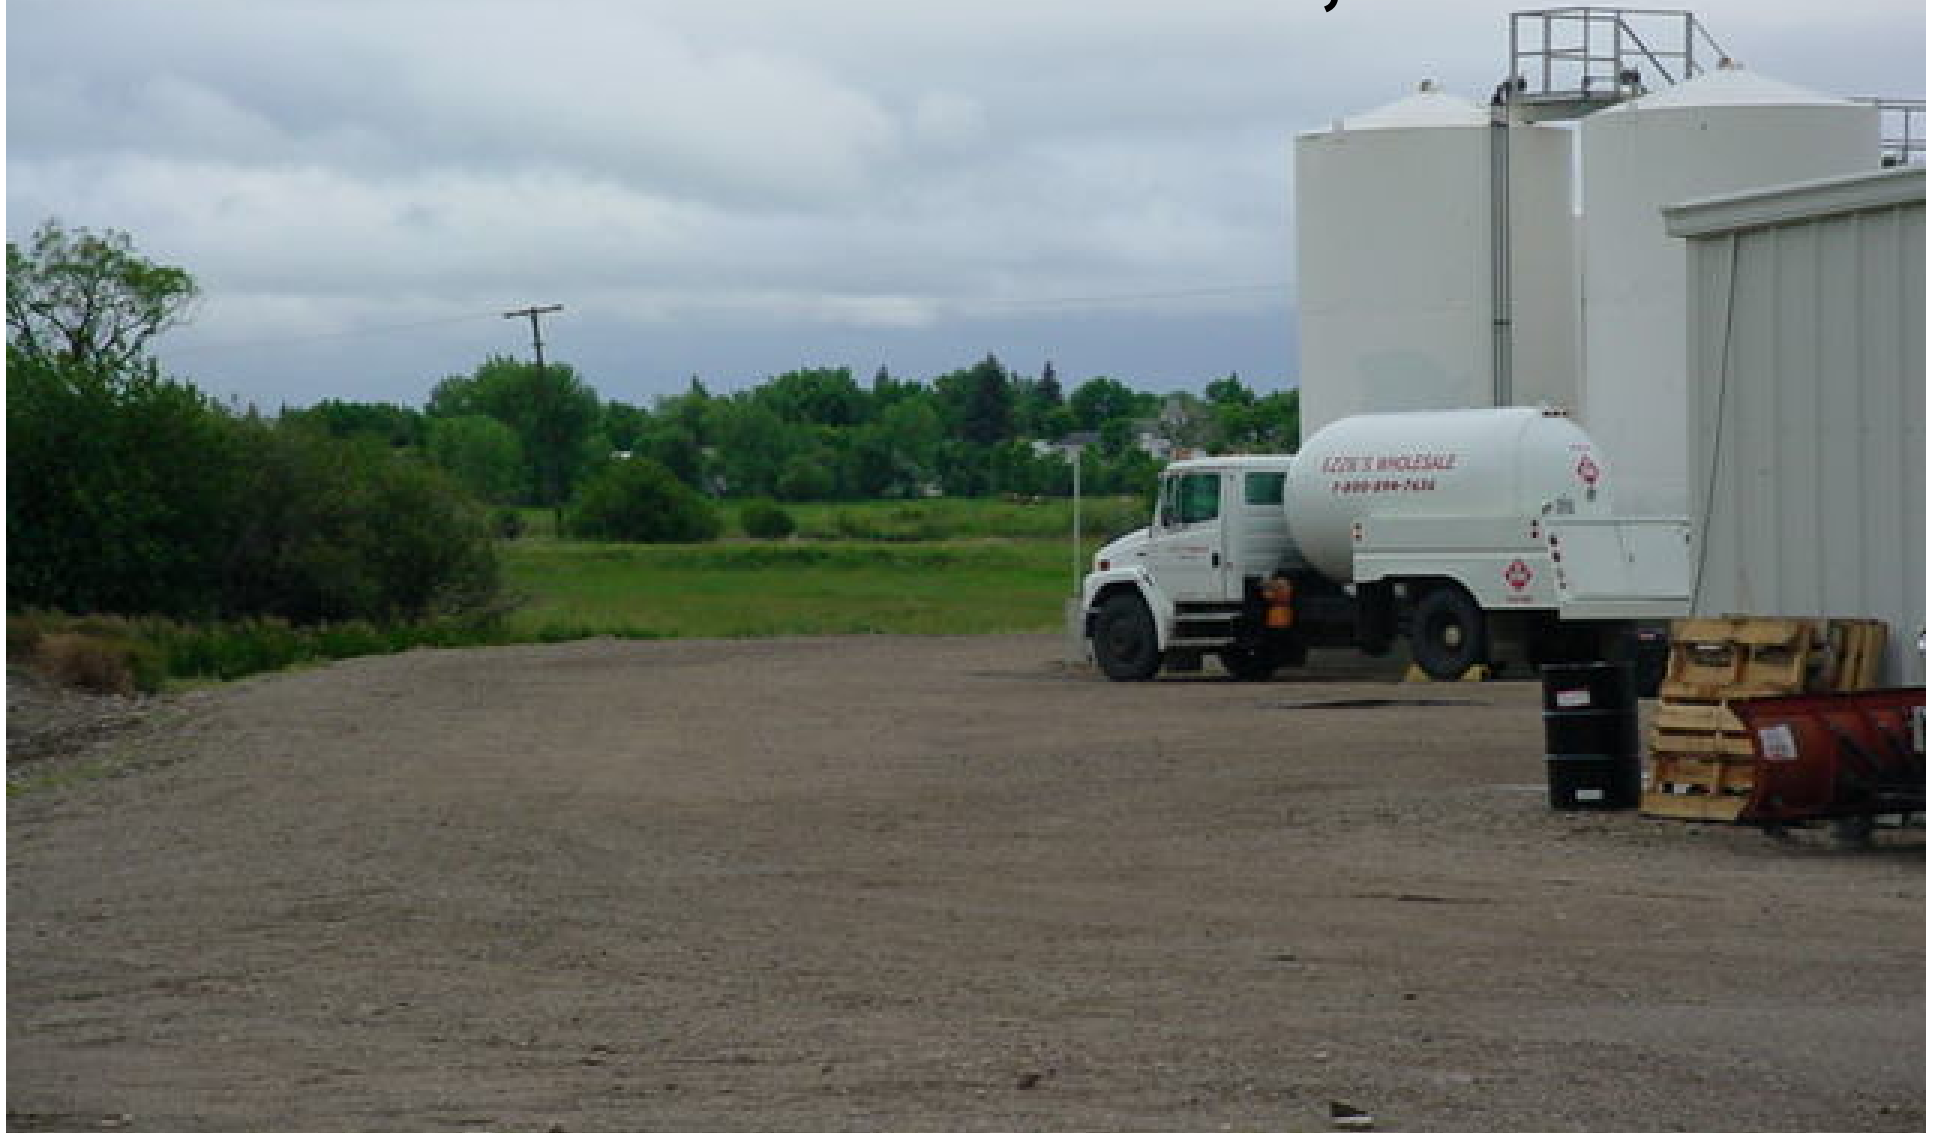
Ezzie's Wholesale: Chinook, MT.

- **Dec. 1995: Leak reported in gasoline supply lines**
- **GW/Soil investigation completed**
- **Fine-grained silty-clay soil**
- **GW 4.5 - 8ft. bgs**
- **High BTEX, TPH in soil and GW**
- **No DW taste or odor complaints**

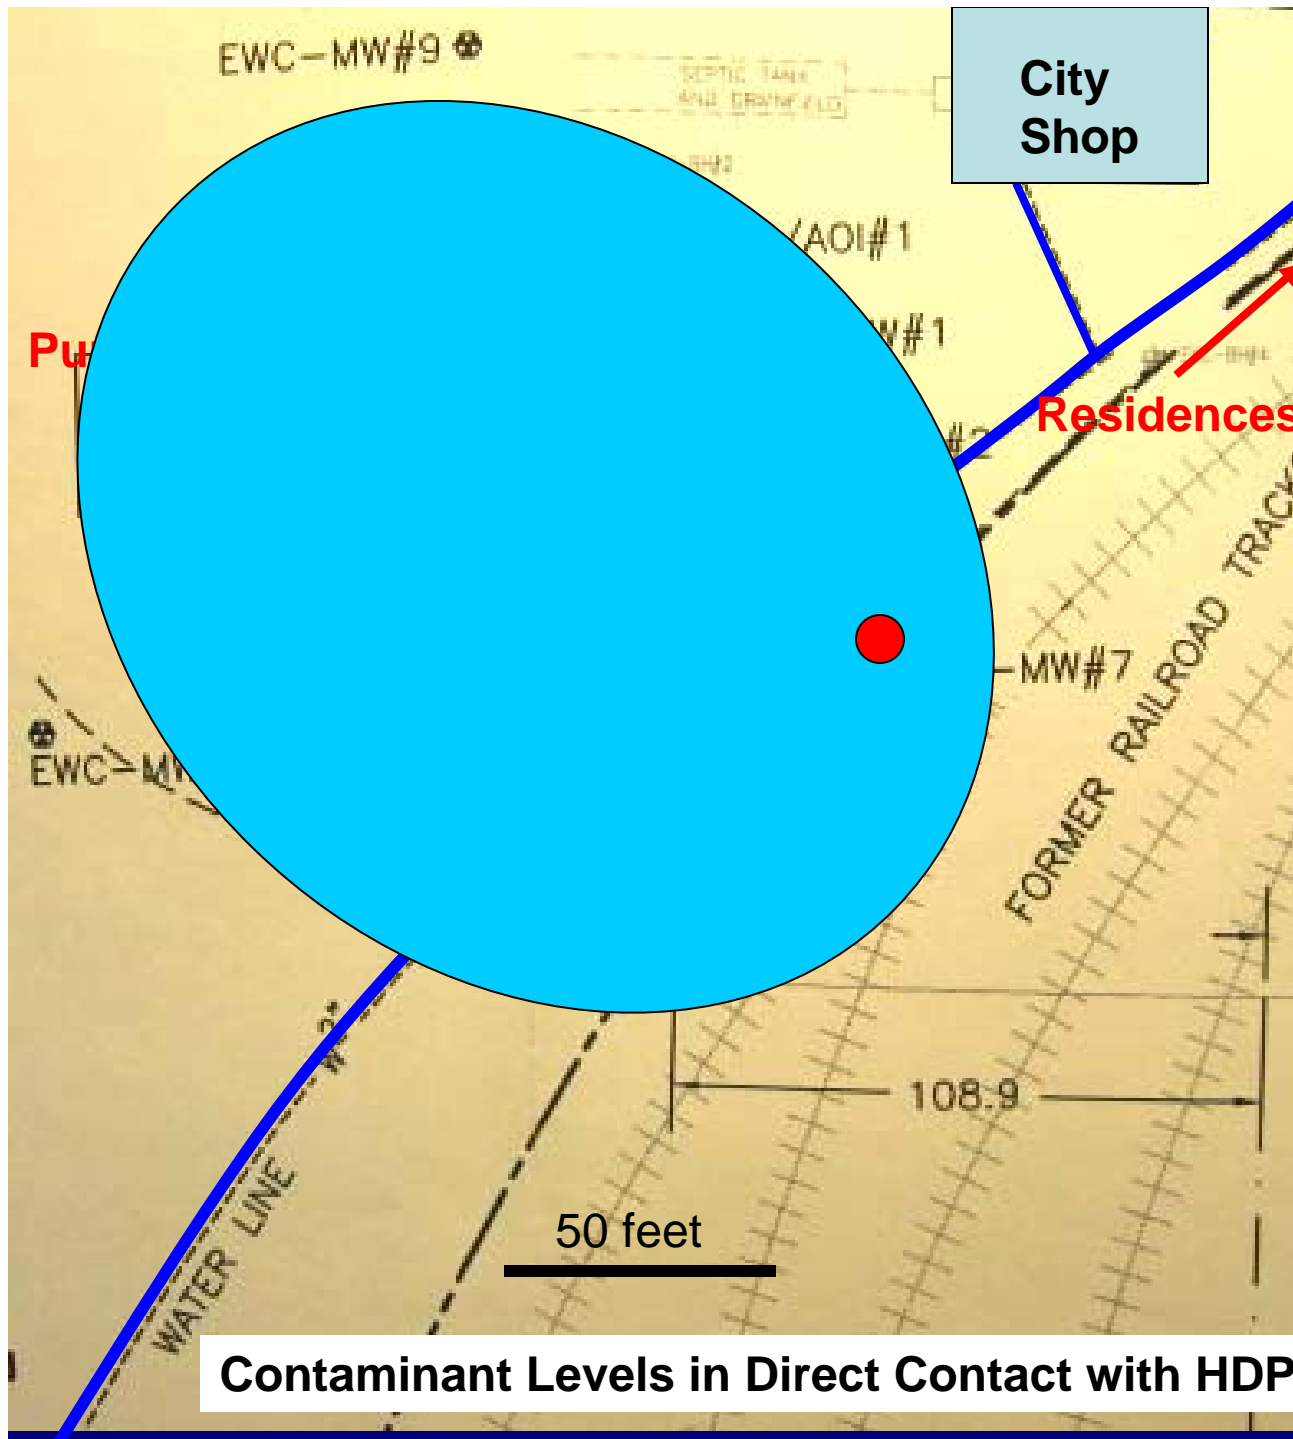
Contaminant Levels in Direct Contact with HDPE Waterline

MW-7

GW approx. 5 – 8 ft. bgs

Benzene range:
13,500 – 34,300
ppb

TPH (total
purgeable):
46,300 -95,700
ppb

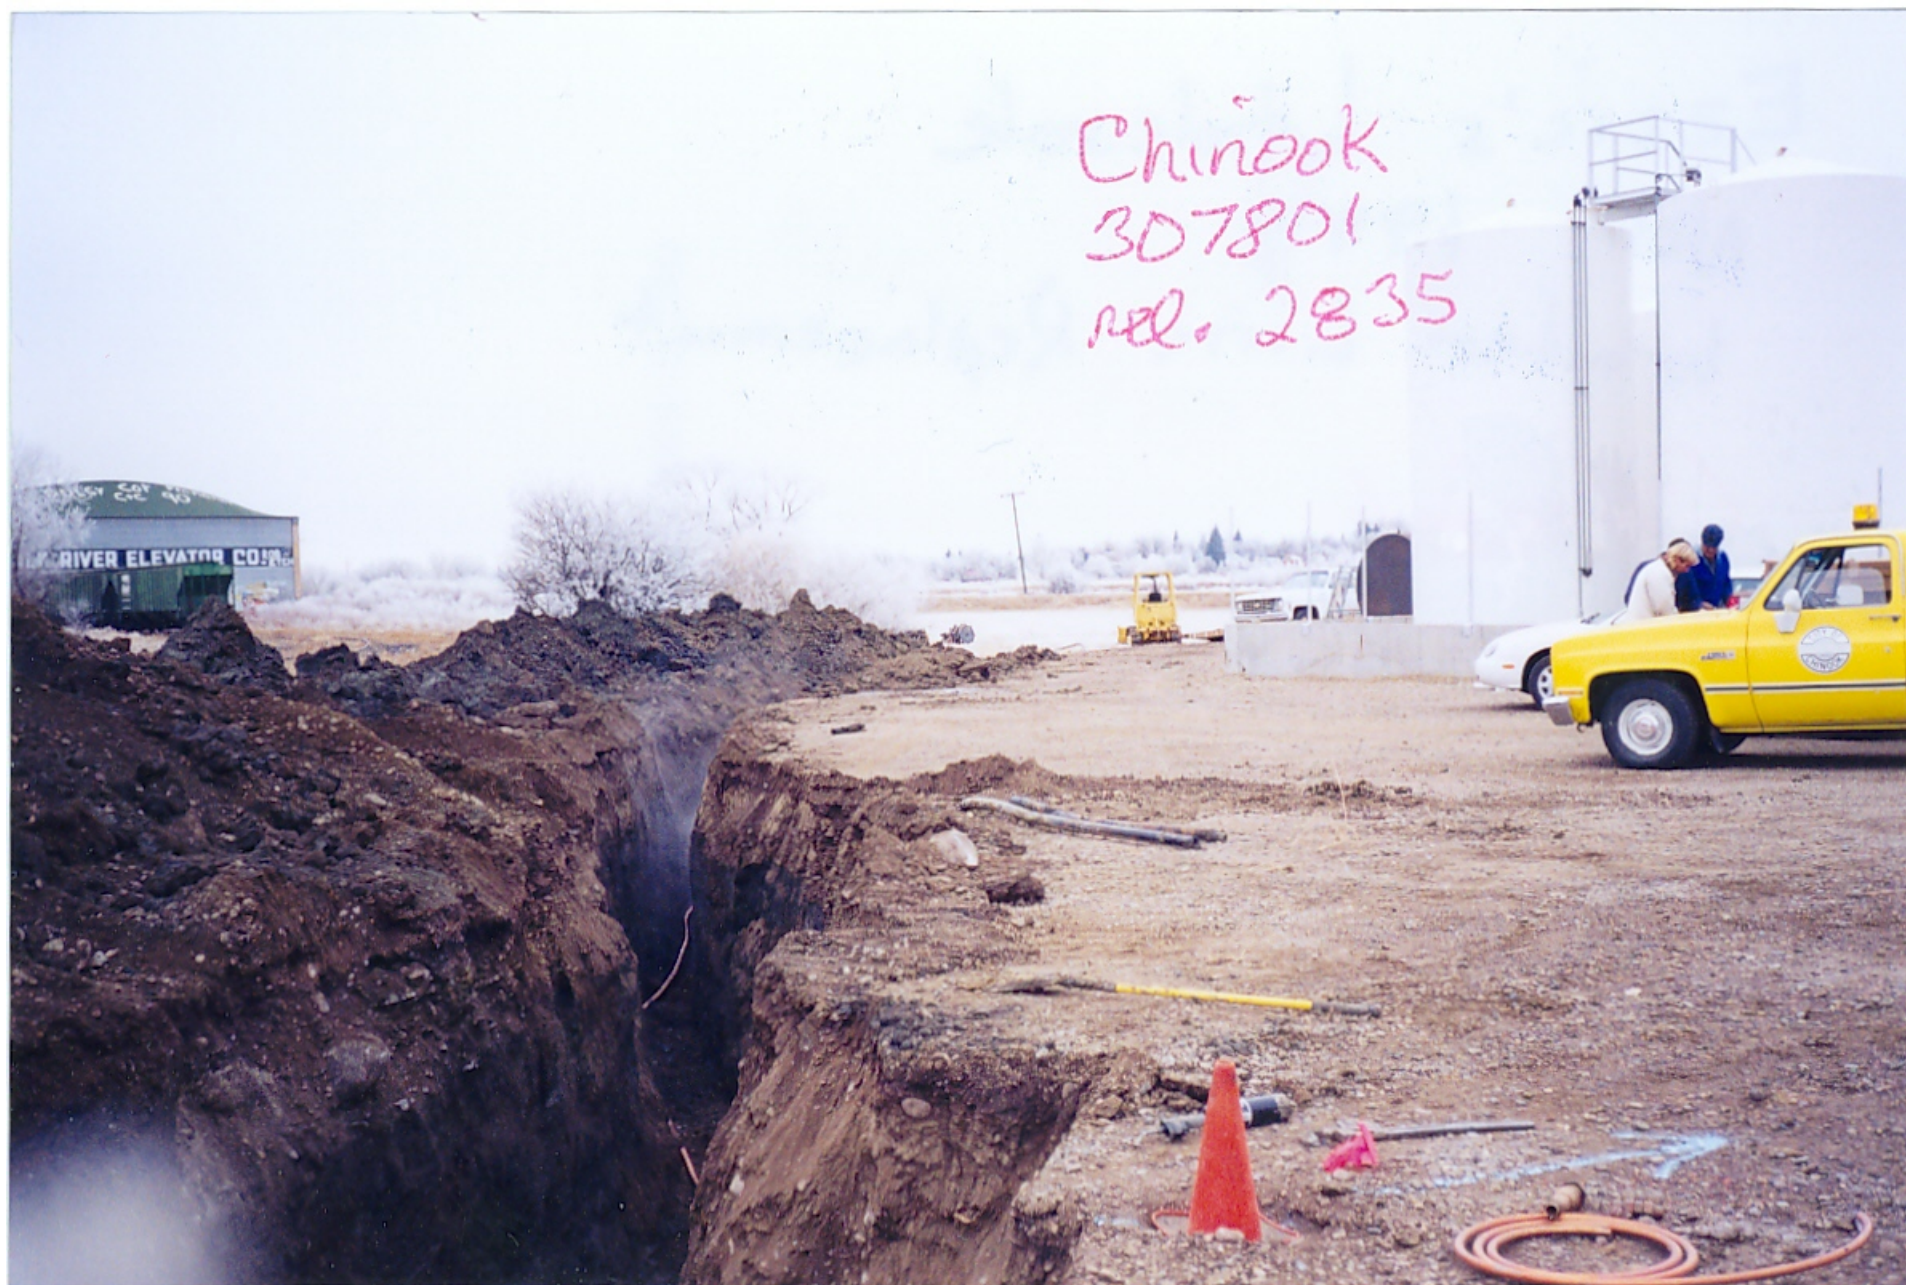
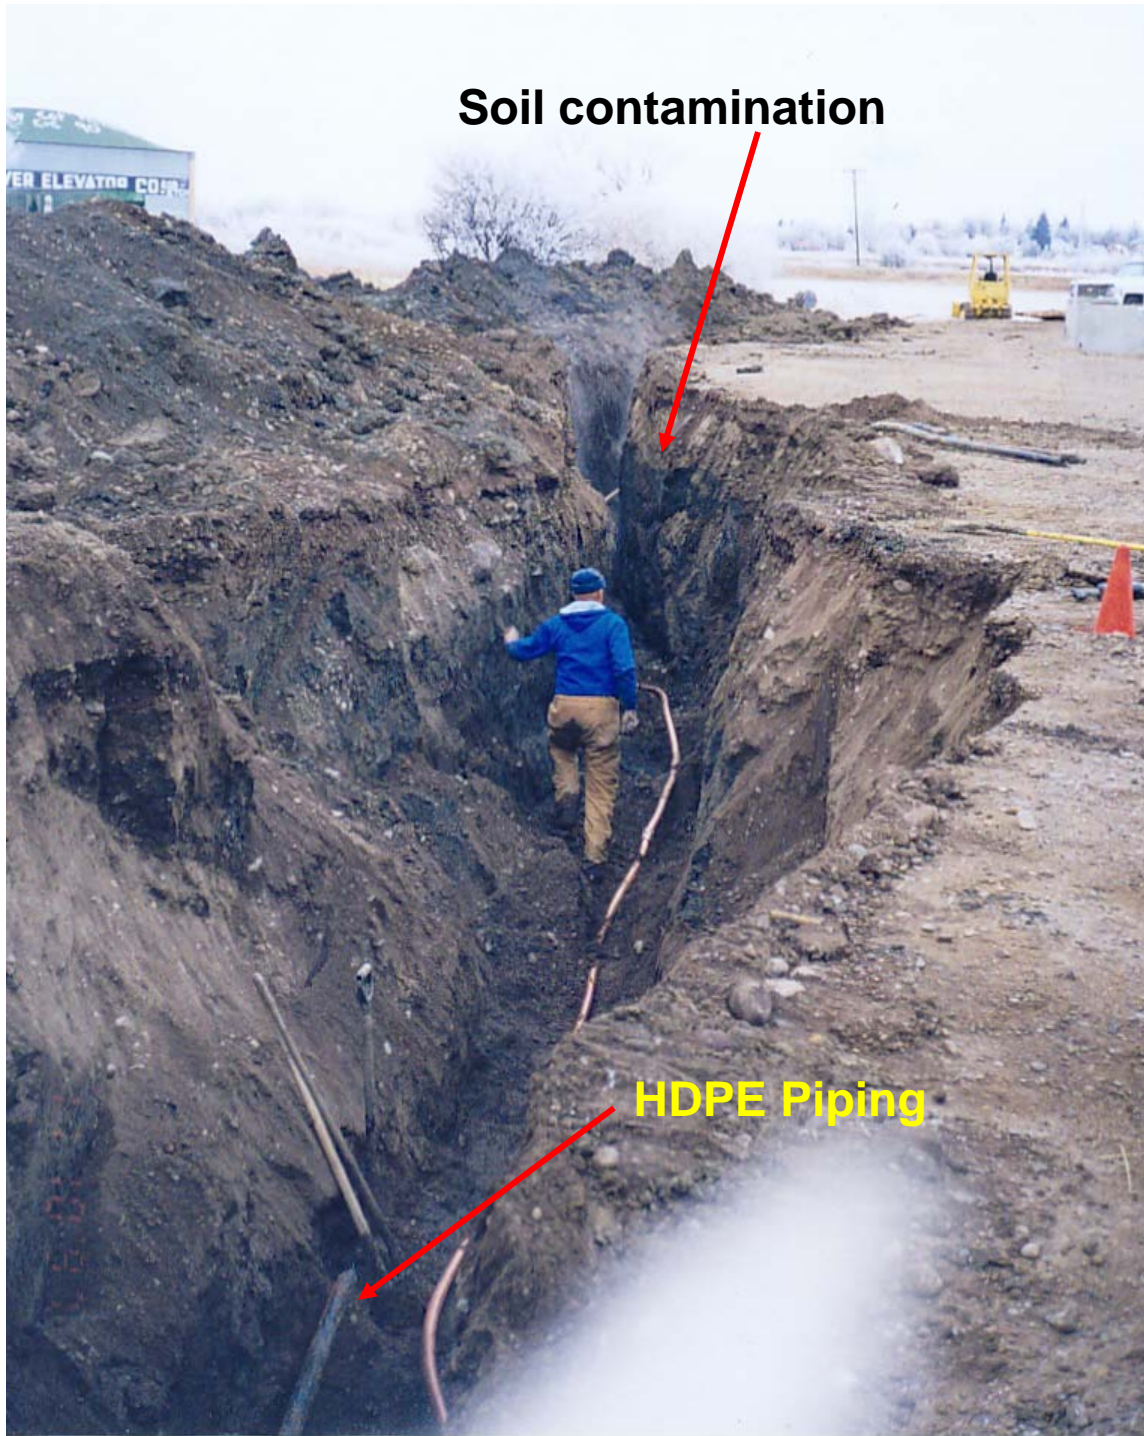
1997 Waterline Replacement

- **Nov. 1997: HDPE Waterline replaced with 1-inch copper line**
- **Adjacent contaminated soil removed and landfarmed**
- **Additional soil removal and site remediation planned for 2007**

Soil contamination

HDPE Piping

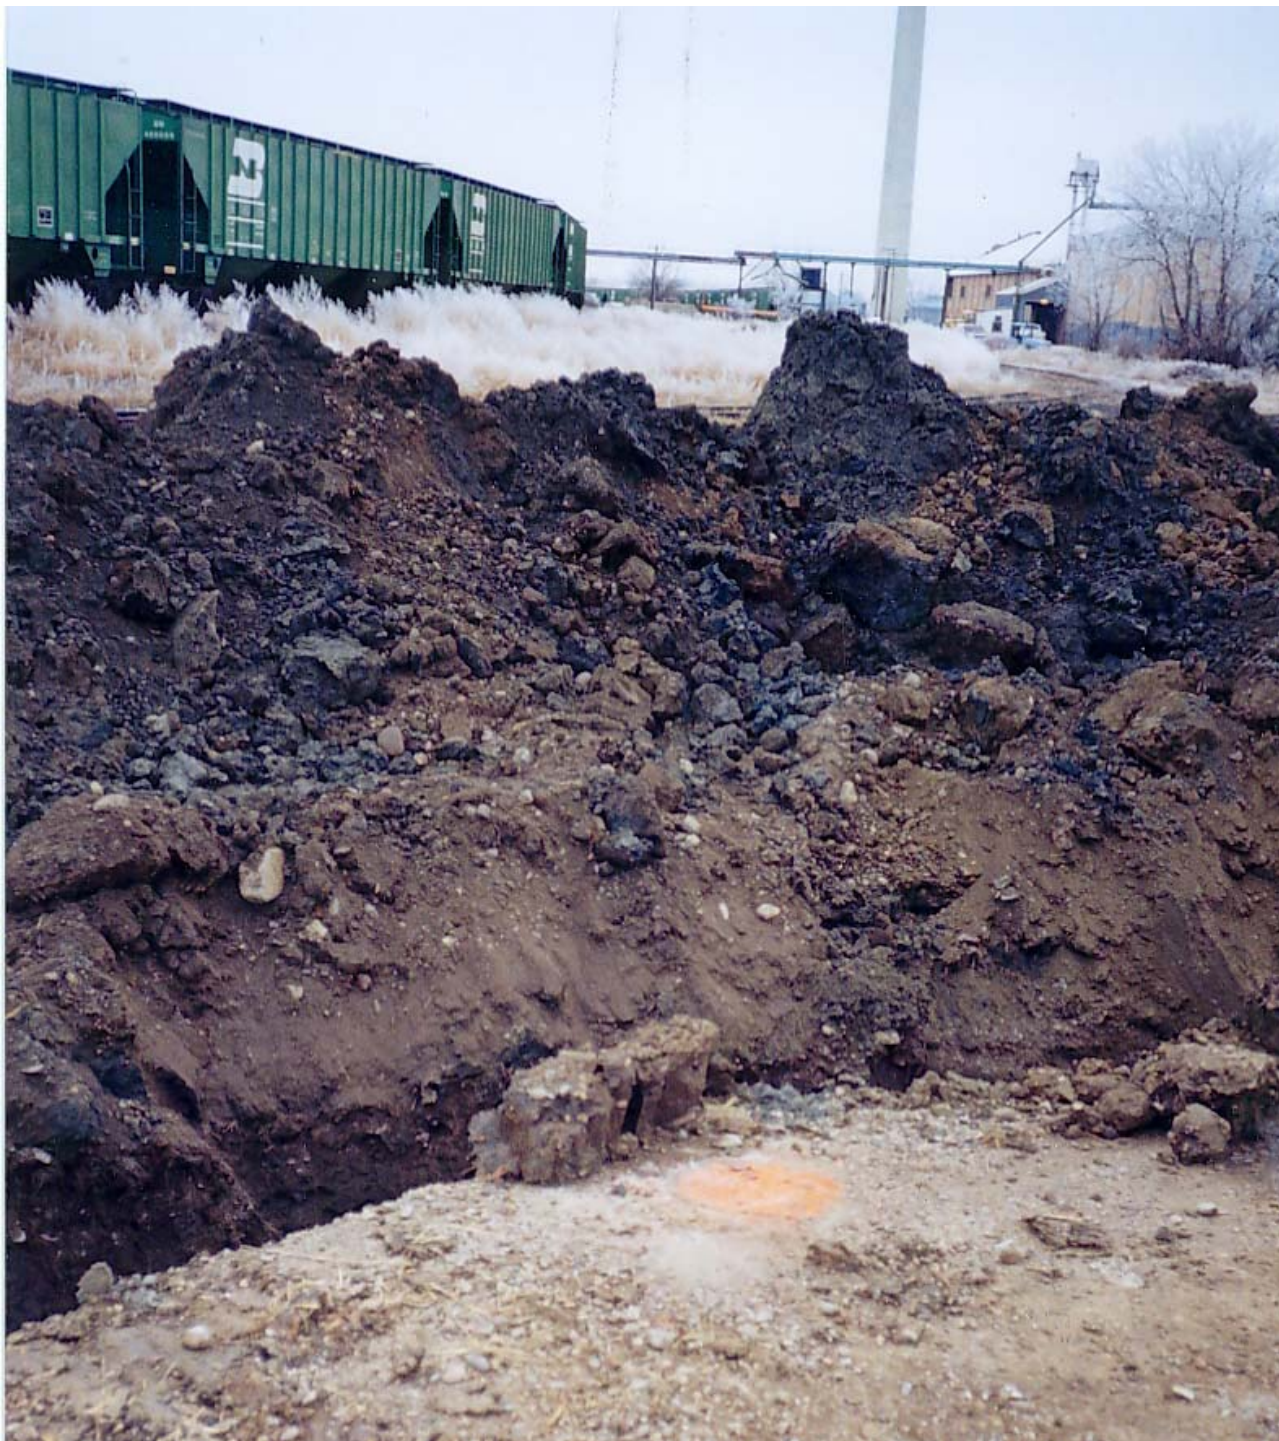
Circle R Services
E. Glacier
Fac. ID# 18-05188 (3603)
11/17/00

O/O noted a “slight odor present” on 30-day release form

PID readings using heated headspace:

>2,000 ppm (Mini-Rae PID)

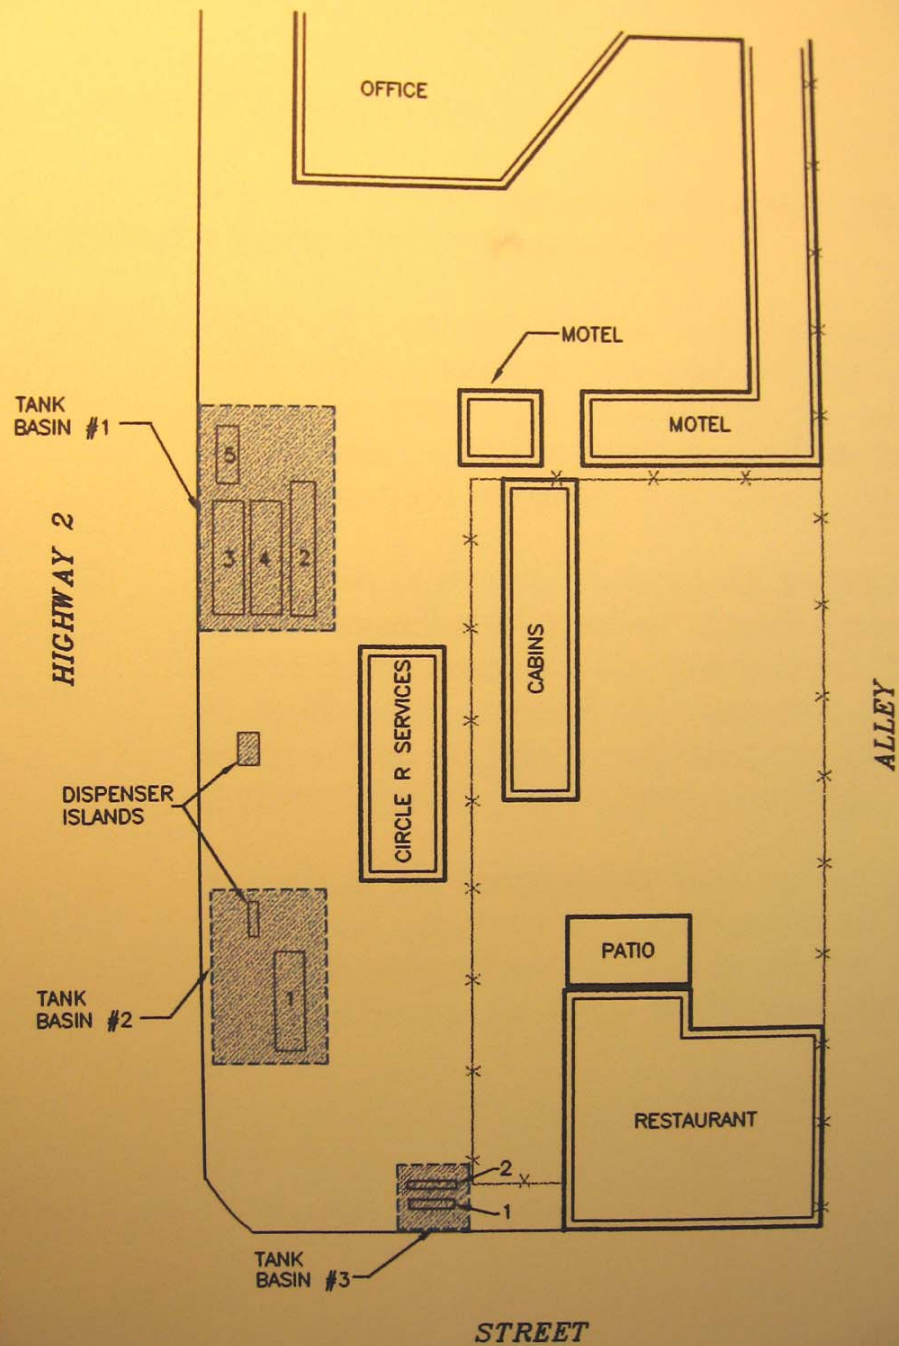
Base Map with UST Basins

- 3 of the 5 MWs had high benzene
- High residual contamination in area between the 2 former UST basins
- Addl. tank basin with 2 USTs (1,000 gal and 2,000 gal.) discovered
- Consultant's recommendation: remove the residual source material

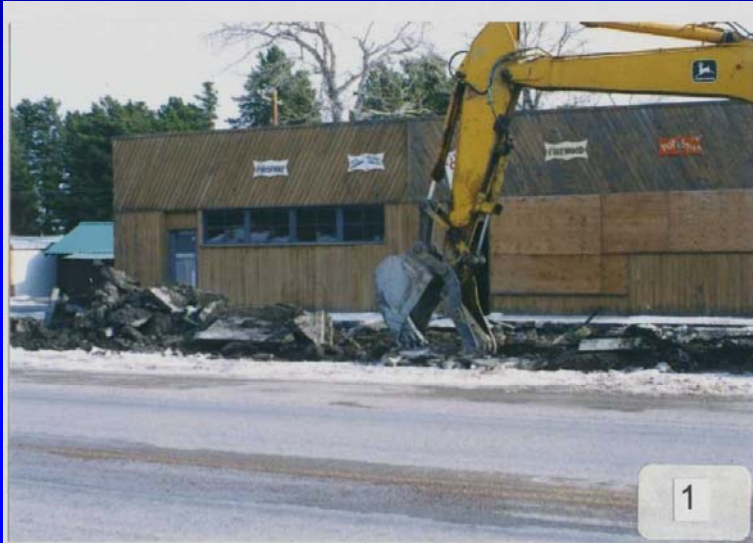
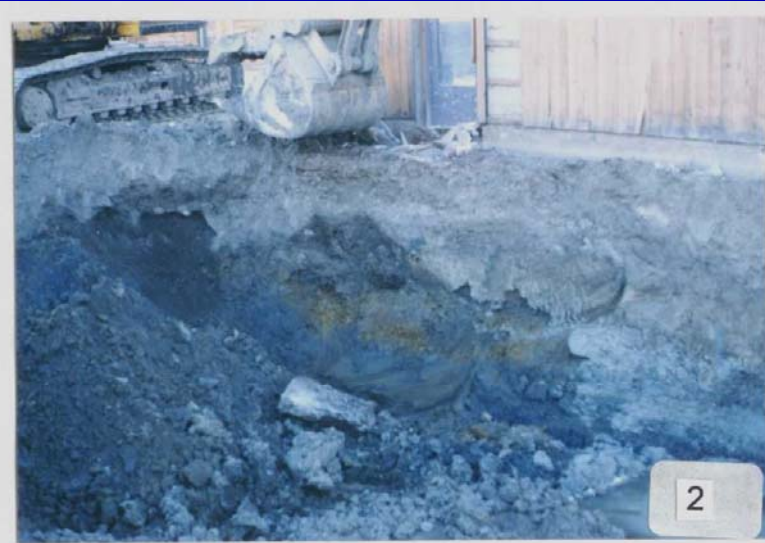
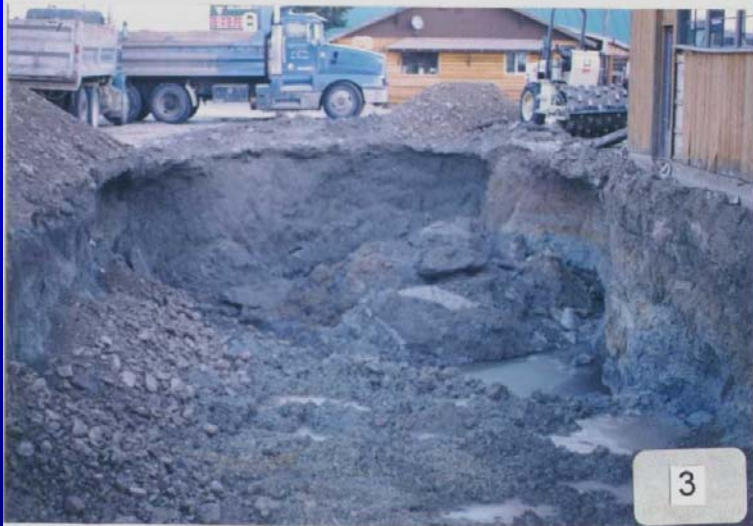
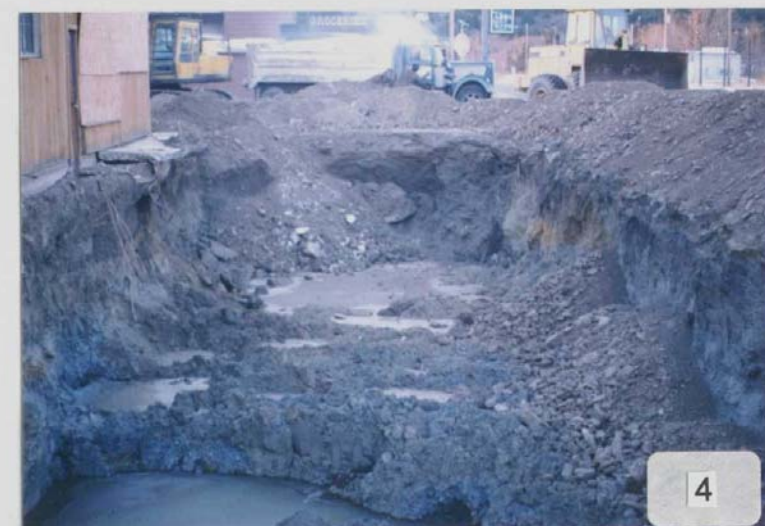
Circle R Services – East Glacier

- **1247 cubic yards removed and landfarmed**
- **MW-2 removed during excavation**
- **Post excavation soil sampling (8 sidewall confirmation samples)**
- **Only 1 benzene exceedance**
- **Very low TPH concentrations**
- **Groundwater sampling: concentrations dropped below standards within 2 quarters**
